Subject: Kitikmeot Heritage Society Cambridge Bay – Proposed Location Assessment (Revised)
O/Ref.: 02110045.000

Englobe Corp. (Englobe) is pleased to provide Pitquhirnikkut Ilihautiniq / Kitikmeot Heritage Society with site selection recommendations for Lot “3A” for the above-mentioned project located in Cambridge Bay, Nunavut (the Site). The report has been prepared "As per CAN/BNQ 2501-500/2017 "Geotech Site Investigations in permafrost zones".

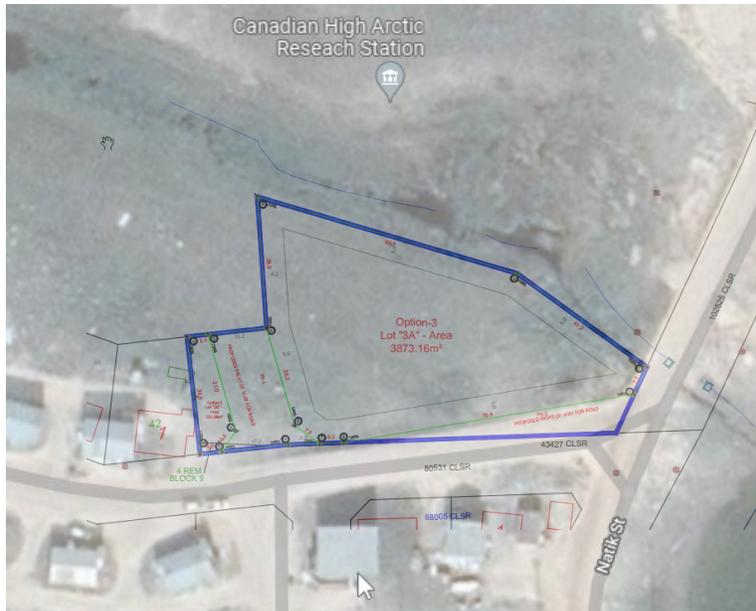
Figure 1 – Aerial Photo Overlain by Proposed Site Area

A proposed Site option was identified by the client for a preliminary site assessment for the proposed knowledge center. Figure 1 shows the proposed plan superimposed over the latest aerial photo (2020).

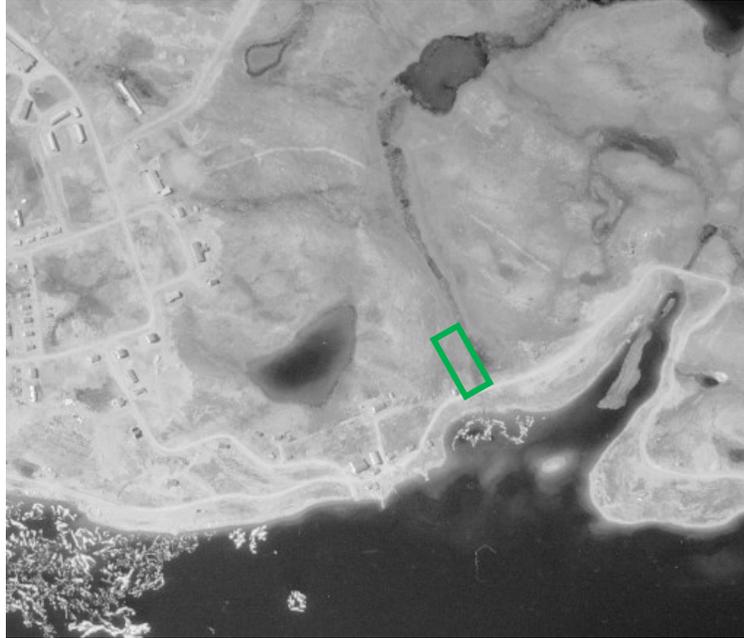
Figure 2 – Aerial Photo of Site Area (1964)

Figures 2 through 4 show historical aerial photos of the site area, which has yet to be developed. The surrounding area to the south and west was developed into residences over the lifetime of the community. Another notable development is the Canadian High Arctic Research Station (CHARS) to the north. As noted in the figures, there is a stream that runs along the north boundary of the Site, and Figure 5, which is a recent photo of the Site shows moderate ponding of water along the east portion of the Site. Additionally, there is a stream that runs along the north boundary of the Site, and water infiltrates the Site from the south. There is little to no vegetation cover throughout the Site.

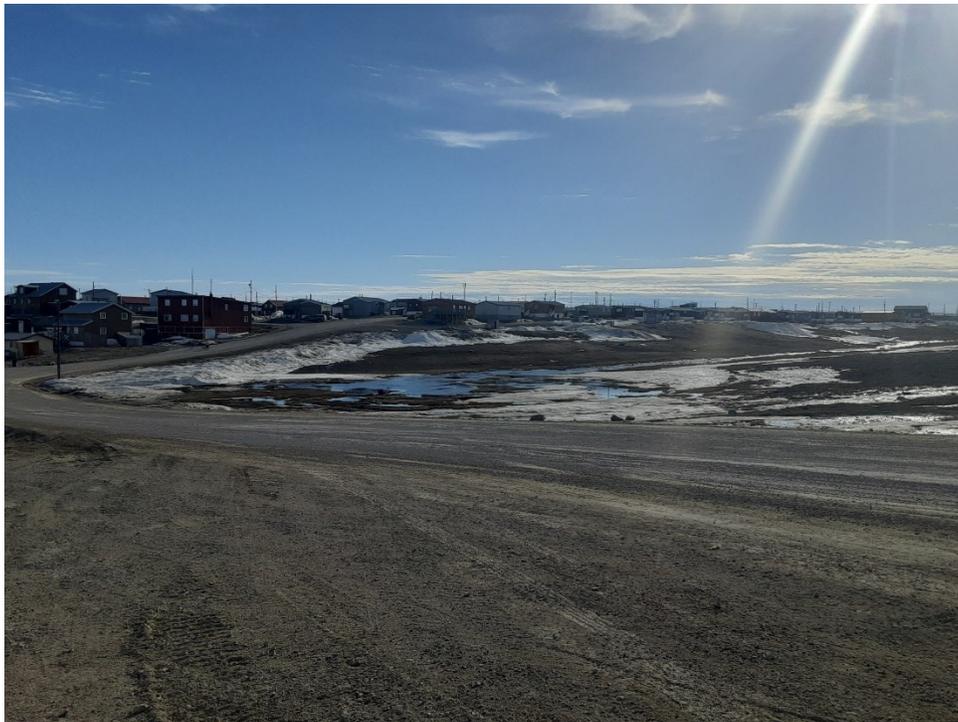
Figure 5 – Photo of Site Area, facing West (2021)

The proposed Site area also lies approximately 1-2m lower relative to the surrounding properties and roads, with the site gently sloping from the southwest towards the north and east.

There is a stream that runs along the north boundary of the site from west to east and releases through a culvert outlet on the east boundary of the Site. There are two culverts in the Site area, with one inlet from the south and one outlet to the east, which should release water away from the Site. Without repairs and/or improvements to the site drainage and existing culverts, increased surface ponding of water will be an issue and must be addressed for the development of the Site. Additionally, due to climate change, increased surface runoff and precipitation is projected, so addressing drainage concerns is dually important.

- ⦿ Specific site grading requirements must be designed by a certified civil engineer;
- ⦿ Two culverts adjacent to the Site to the south and east will need to be repaired/upgraded to discourage ponding of water onsite;

- ⦿ If possible, the proposed development should be built on the western portion of the Site, to mitigate issues due to surface water runoff and ponding noted on the eastern portion of the Site;

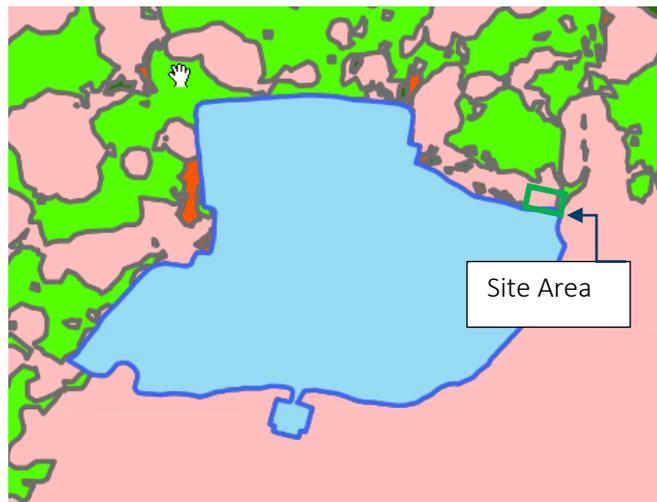
The figure below roughly shows the location of the proposed Site for the proposed knowledge center with a legend regarding development suitability. The proposed Site lies mainly in what is classified as an unsuitable area based on the criteria below.

Although the site area lies within what is classified by the report as an unsuitable area, the site would be rendered suitable for development with proper improvements to the site as noted in the recommendations in Section 1.8.

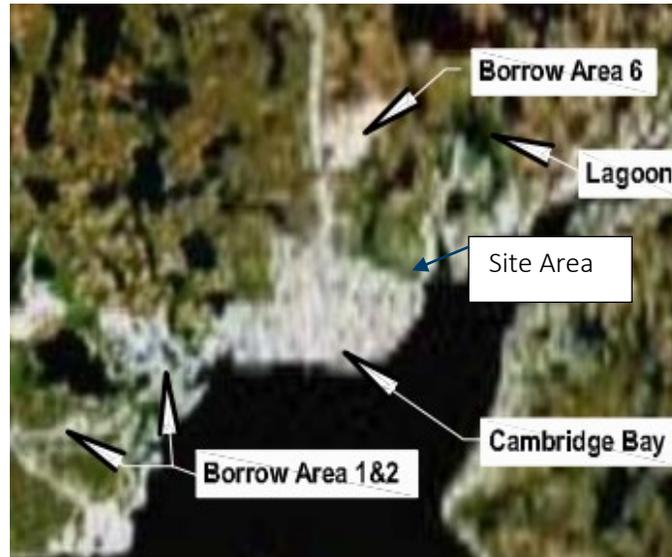
Figure 6 – Prospective Borrow Sites

After a review of these reports, several prospective borrow sites were identified in Figure 6 below.

Borrow areas 1 and 2 are located approximately 1.5 km southwest of the Hamlet of Cambridge Bay. Borrow area 6 is located approximately 1.0 km north of Hamlet. It is noted that a crusher is available within Cambridge Bay. With sufficient processing, there would be a material suitable for 75 mm minus gravel, or even 25 mm minus gravel.
